National Highway Traffic Safety Administration

ON-SITE AIR BAG INVESTIGATION

CASE NO. - 96-12 FLEET - PRIVATE VEHICLE LOCATION - NORTH CAROLINA ACCIDENT DATE - 1996

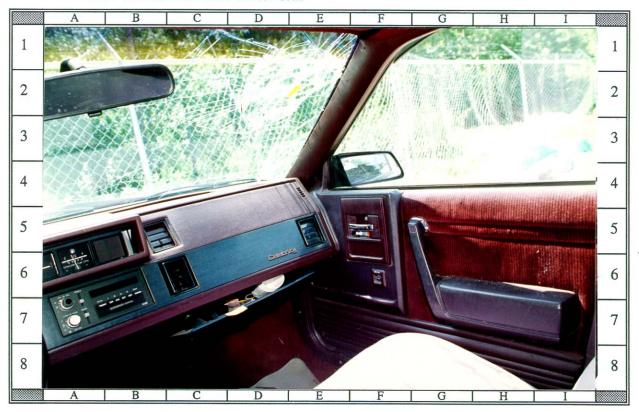
86: Vehicle #2's contacted right windshield and lower dash; NOTE: driver was unbelted and thrown towards 2 o'clock PDOF

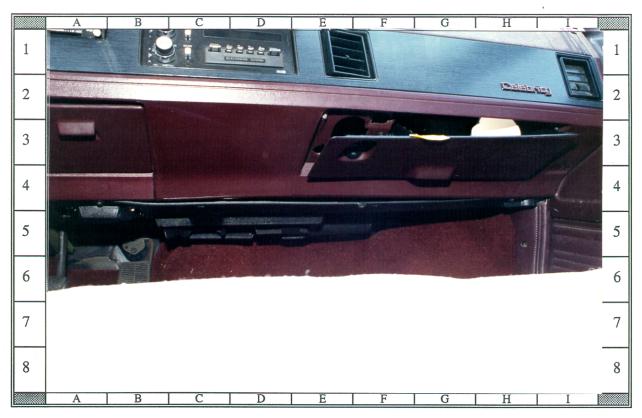
#87: Close-up of Vehicle #2's broken glovebox from driver contact

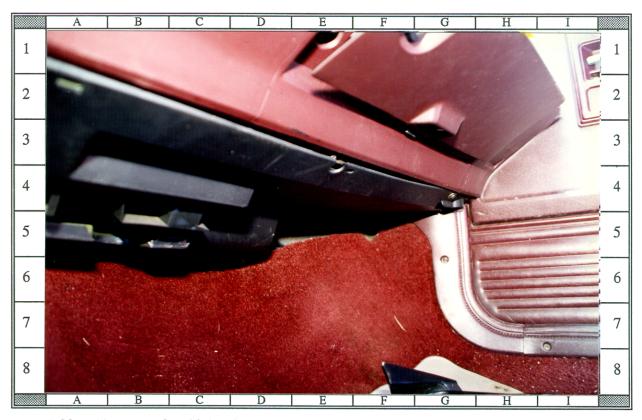
88: Close-up of Vehicle #2's toepan area showing minor intrusion

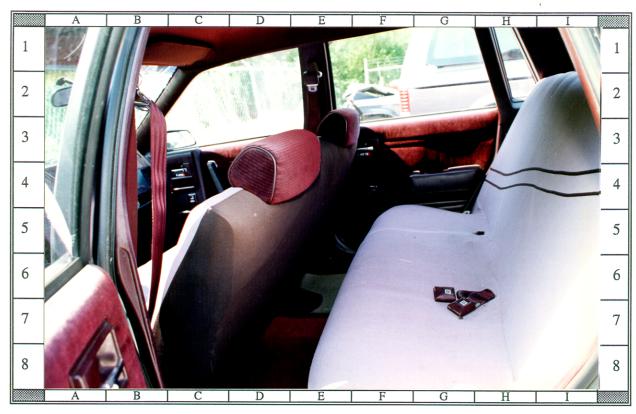
89: Vehicle #2's rear seating area; NOTE: front seat headrests and outboard, 3-point safety belts, and three, 2-point, lap belts in rear seating area

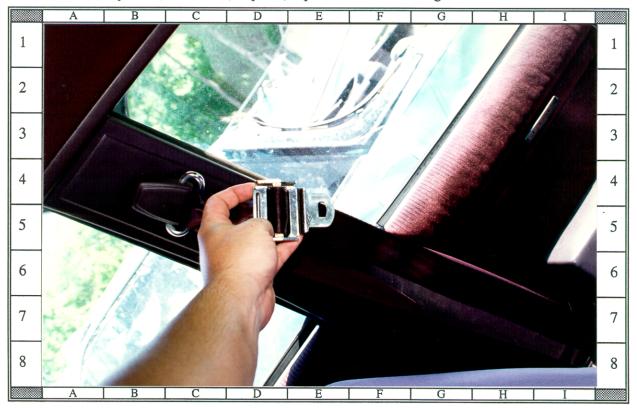
90: Vehicle #2's driver seatbelt showing signs of previous usage
